Technical Correspondence

HUM PROBLEMS WHEN SWITCHING THE K9AY LOOPS

By Gary Breed, K9AY, 2395 Camp Mitchell Rd, Grayson, GA 30017, e-mail gary@noblepub.com

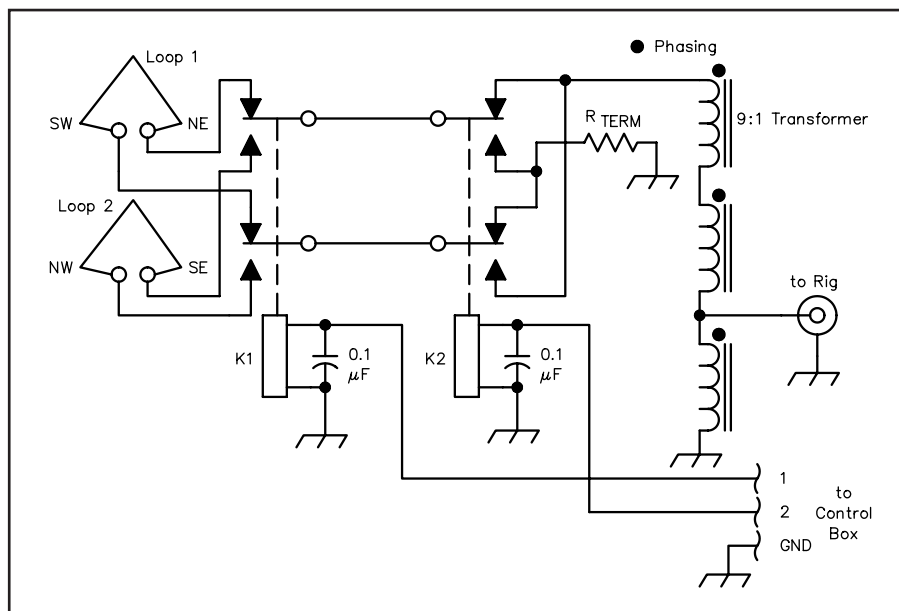
There is one problem that needs to be addressed. When the loops are switched to the northwest direction, an ac voltage is sent down the coax to the relay box. A few hams have reported hum or distortion when the antenna is switched in this direction. Two explanations are possible: a ground loop due to widely separated antenna and station grounds, or modulation of the core of the matching transformer. The presence of hum was not evident in my prototype, but to avoid either cause of the problem, I recommend using a *separate* three-conductor control wire to operate the relays. The power is solely 12 V dc, and no current flows through the transformer. The modifications are shown in the accompanying figures, which can replace Figures 5 and 6 in the original article.

Figure 1—A revision of the schematic shown in Figure 5 of the September 1997 *QST* article.

Secondary benefits of this arrangement include the option of using an existing 12 V power supply to provide the operating voltage, and the ability to use an additional conductor to carry power to an antenna-mounted preamplifier.

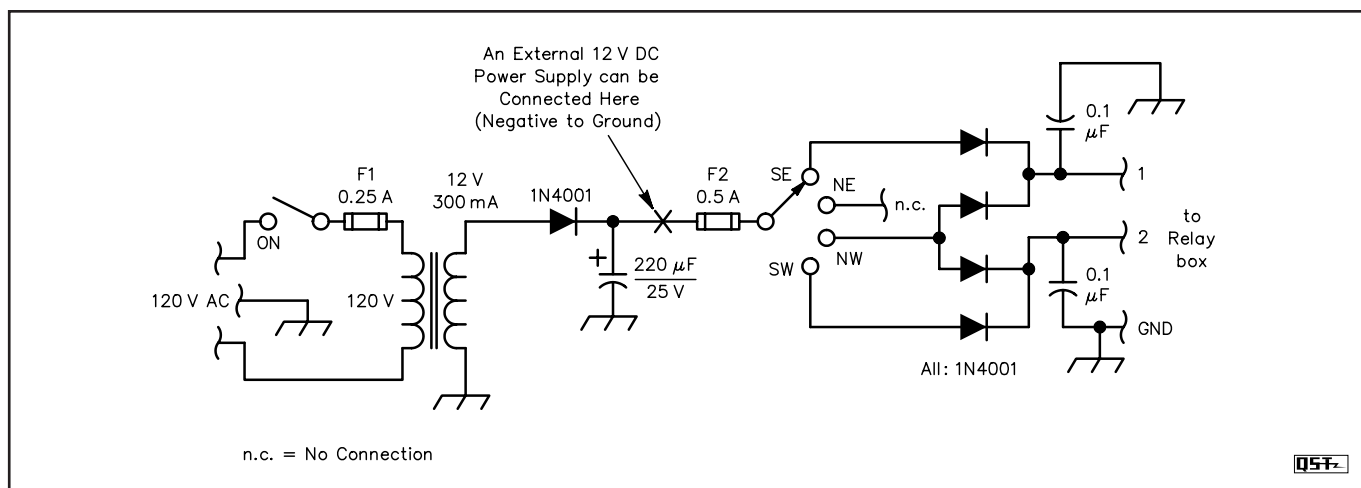
Figure 2—Changes to Figure 6 of the original article.
